STONE BASED SMART AGGREGATE FOR STRUCTURAL HEALTH MONITORING OF RC COLUMNS UNDER SEISMIC EXCITATIONS

ABSTRACT

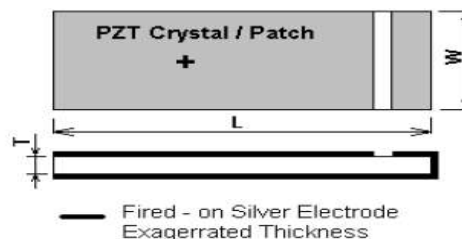
In PZT plates, the major faces are electroded. When these plates are to be glued to a surface / structure, one has to provide electrical connections to the bonded surface also. In order to facilitate electrical connections on one side, the bottom electrode (which is bonded to the structure) is brought to un-bonded surface so that both the lead-wires are connected on one side.

Fig:2 Geometry Of PZT

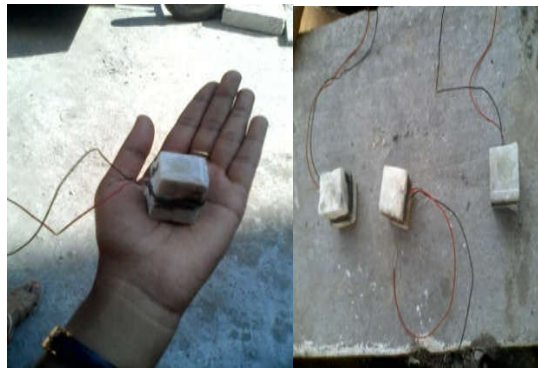
The proposed SA consists of a piece of PZT patch connected with a piece of two-wire cable and a pair of marble blocks. The commercially available soft PZT ceramic referred to as P-5H with a major composition of $\text{Pb}(\text{TiZr})\text{O}_3$ was chosen. The PZT's properties, measured by the supplier, are listed in Table1 . Young's modulus of the marble and the epoxy was 51.5GPa and 2.5GPa, respectively, as supplied by the manufacturer. The size of the PZT patch was 15×15 mm, and the thickness was 0.4 mm. The marble blocks were $25 \times 25 \times 12$ mm in size. When the marble blocks were aligned together along the 12mm long edge, a hole with a diameter of 3mm and depth of 10mm was bored to accommodate the cable and the soldering points on the PZT patch. Then the PZT patch was sandwiched between the marble-block pair with structural Araldite epoxy-resin. The calibration test had been conducted and showed that the SA had constant sensitivity at a relatively high stress level. Sensitivity obtained from the calibration test was 1.23×10^5 pC/MPa.

Fig:3 Fabricated Smart Aggregate

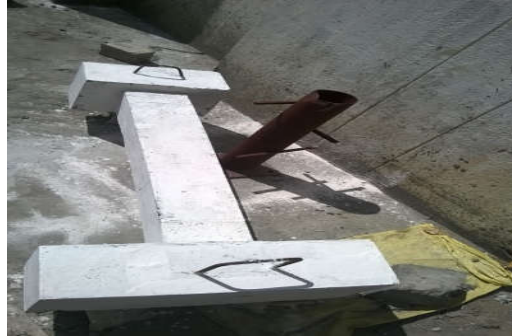
FIG:4 RC Column Specimen

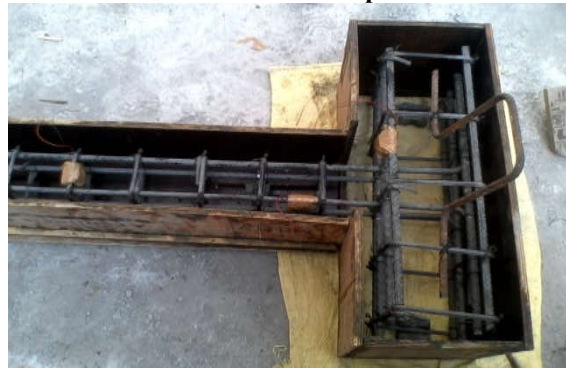
Fig:5 Column Setup Embedded With SA

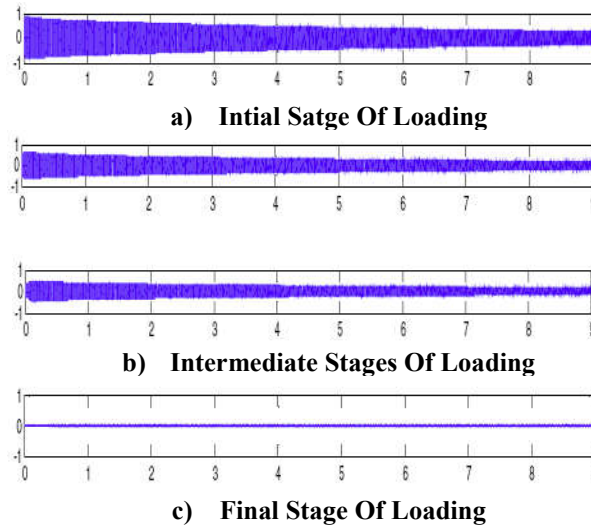
Fig:8 Result Showing Decrease In Voltage After Cyclic Loading Of Specimen At Each Step Taken By Dso.

In later test due to loading, damage occurs, in which the waves with lower frequencies attenuate much less than those with higher frequencies. For the time history response of the PZT sensor during each test, the magnitude decreases with time. Since the excitation signal was a sweep sine wave from a low frequency (750KHz) to a high frequency (2MHz) with respect to time, it can be concluded that the PZT sensor magnitude decreases with the increasing wave frequency, i.e., the waves with lower frequencies attenuate much less than those with higher frequencies.

A dramatic drop in sensor responses means dramatic increases in crack width, which is often caused by structural failure. It is noted that there is a dramatic reduction of the sensor output from test 6 to test 7, which means the damage in the structure, mainly cracks, became so severe.
